CIRCULAR

GME EPIRB Model Safety Alert

EPIRB PRECAUTIONARY SAFETY ALERT

DATE: NOVEMBER 4 2013
EFFECTIVE: IMMEDIATELY

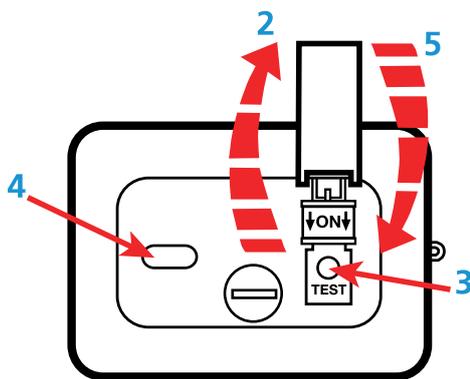
Owners of all GME EPIRBs are required to undertake an immediate test of their beacon using the following procedure:

1. Remove the beacon from the bracket. Keep the antenna well clear of metallic objects during testing.
2. Lift the cover marked 'LIFT'.
3. Briefly press then release the yellow 'TEST' button.
4. The unit will give a double beep and flash of the strobe light to show it is functioning correctly.
5. Close the switch cover and press firmly into place until it clicks.
6. Return the beacon into the bracket.
